Breakdown Degradation Associated With Elementary Screw Dislocations in 4H-SiC p⁺n Junction Rectifiers

Phil Neudeck
NASA Lewis Research Center

Materials Research Society 1997 Fall Meeting
Boston, MA
December 1-5, 1997

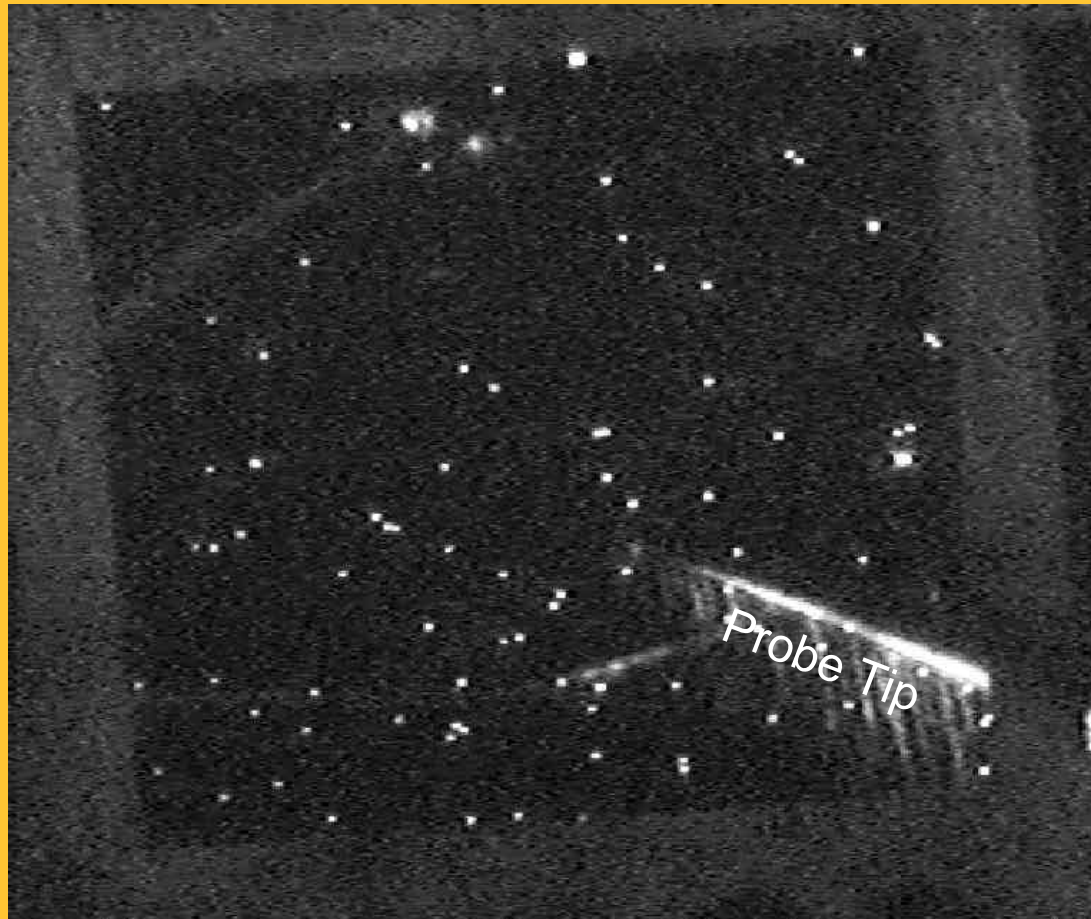
Low-light optical micrograph of 0.9 x 0.9 mm 4H-SiC
p⁺n diode biased in reverse breakdown
(probing p⁺ cap layer with no contact metal)

Device with no micropipes.

Nonuniform breakdown.

“Constellation” of reproducible
breakdown microplasmas.

Microplasma density
consistent with known
elementary screw
dislocation densities.

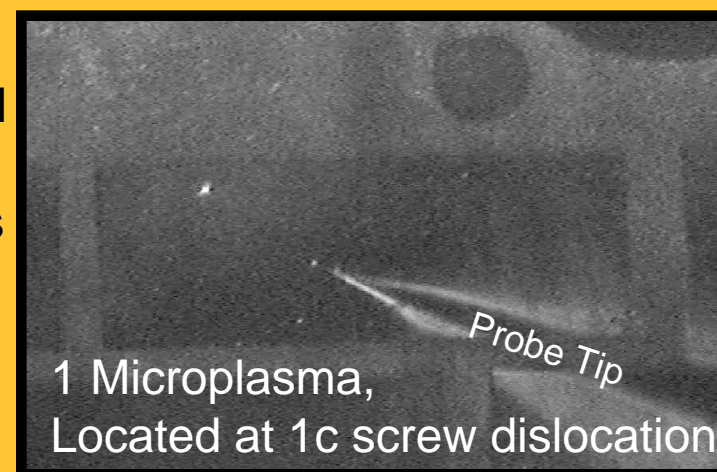
Breakdown Microplasma Corresponds to 1c Screw Dislocation

Diode without 1c screw dislocation

X-Ray
Topographic
Images of
Rectangular
Diodes on
Same Wafer.

Diode with 1c screw dislocation

Low-light Optical
Micrographs of
Breakdown-Bias
Luminescence

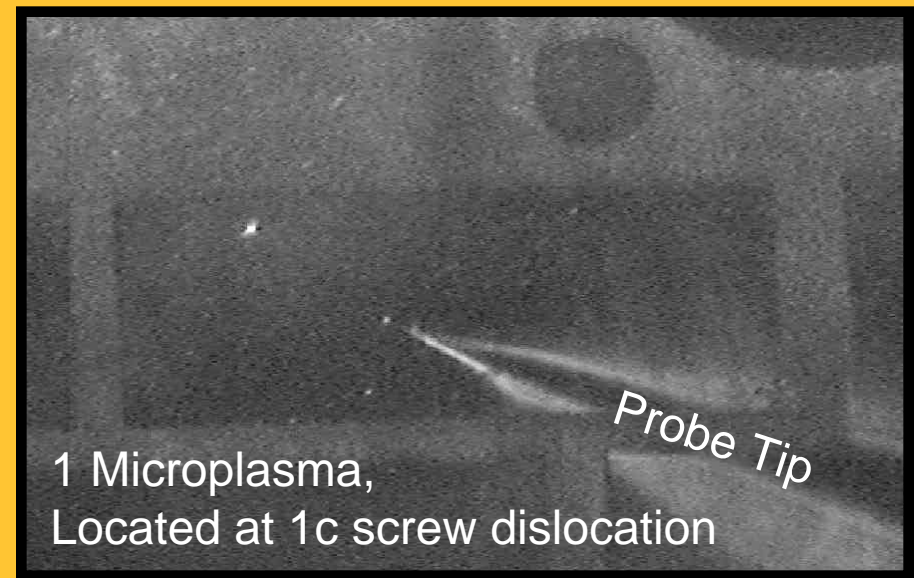
Microplasma Characteristics

Microplasma turn-on

Low-Light Optical Micrograph of Breakdown-Bias Luminescence

- Microplasma turn-on coincides with measured current increase.
- Microplasma physical size less than $5\text{ }\mu\text{m}$, located at 1c screw dislocation.
- All measured current between 65 V and 90 V is flowing at screw dislocation.
- Microplasma DC power density $> 10\text{ kW/cm}^2$, dissipated in $< 0.3\%$ of device area.
- Non-destructive under small-area contactless measurement conditions.
 - Not representative of actual power device operating conditions.

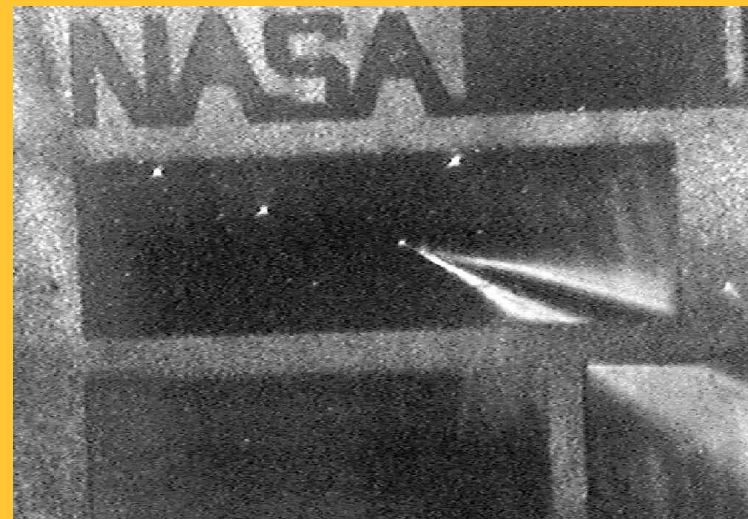
Without exception, every diode that SWBXT identified as containing an elementary screw dislocation exhibited degraded reverse I-V and microplasmic breakdown.
